AROUND THE WORLD WITH CONCRETE

Grout And Shotcrete Put Derailed Japanese Railway Tunnel Back On Track

By Ashraf M. Ghaly, PE, Ph.D.

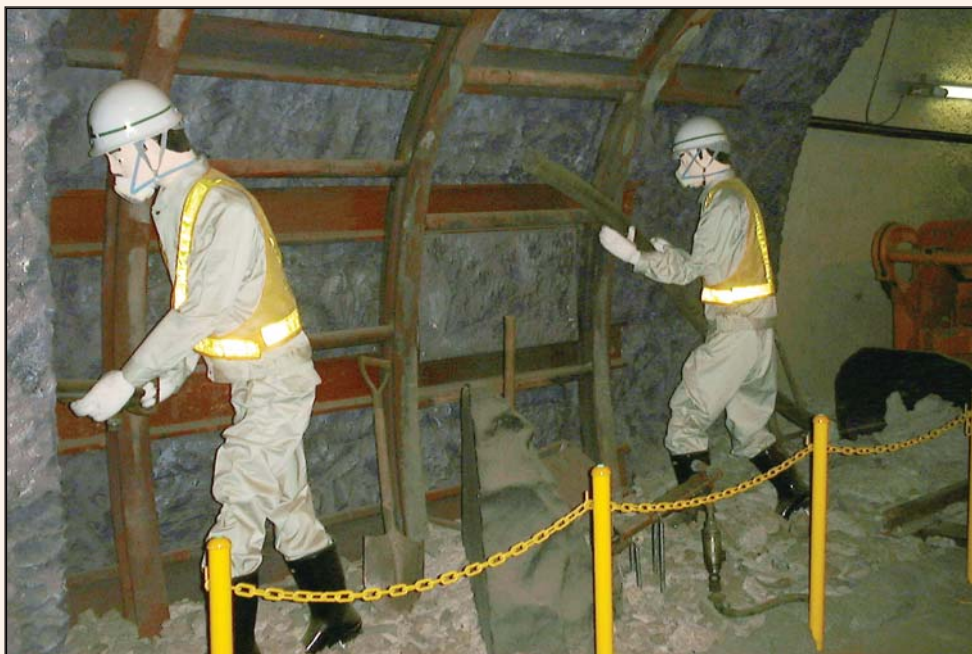
Fig. 4. A model view of shotcrete pump operator.

After the detonation of every charge, the walls were sprayed with shotcrete for primary stabilization then lined with steel H-section supports and a layer of 2 to 3 feet thick

concrete (Figure 4).

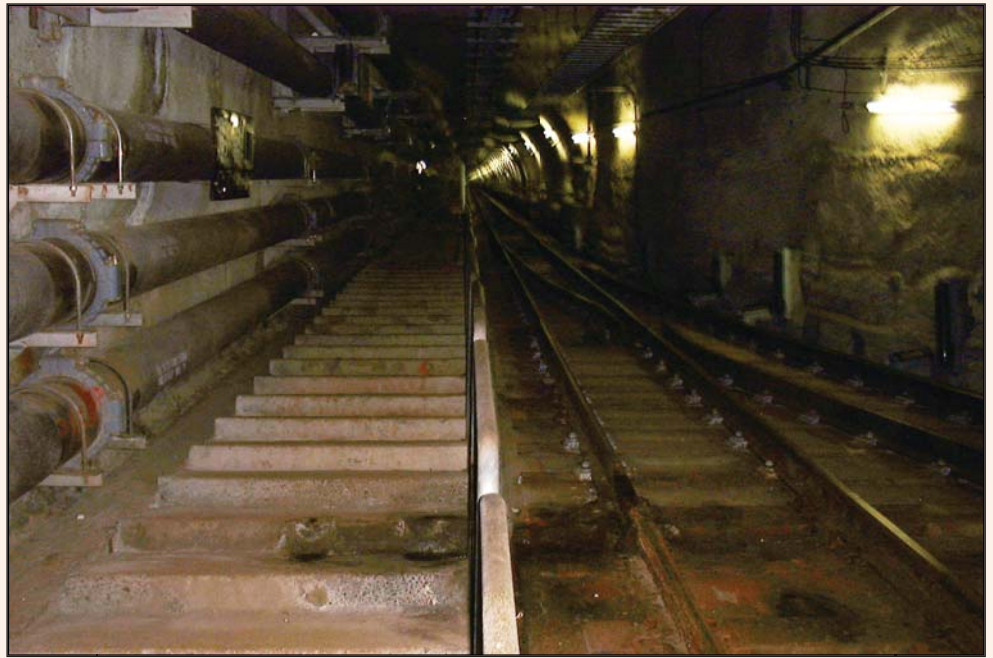
Fig. 5. The inside of Seikan Tunnel.

escaping to the service tunnel in case of a fire. The tunnel is also provided with elaborate heat detection systems, sprinklers, and smoke exhaust blowers. At its deepest point the tunnel reaches 787 feet below the sea (Figure 5). The total cost of the tunnel amounted to \$8.3 billion versus the original estimate of \$783 million.
